Hot Corrosion of Single-Crystal NiAl-X Alloys

James A. Nesbitt
Lewis Research Center, Cleveland, Ohio

National Aeronautics and
Space Administration

May 1998

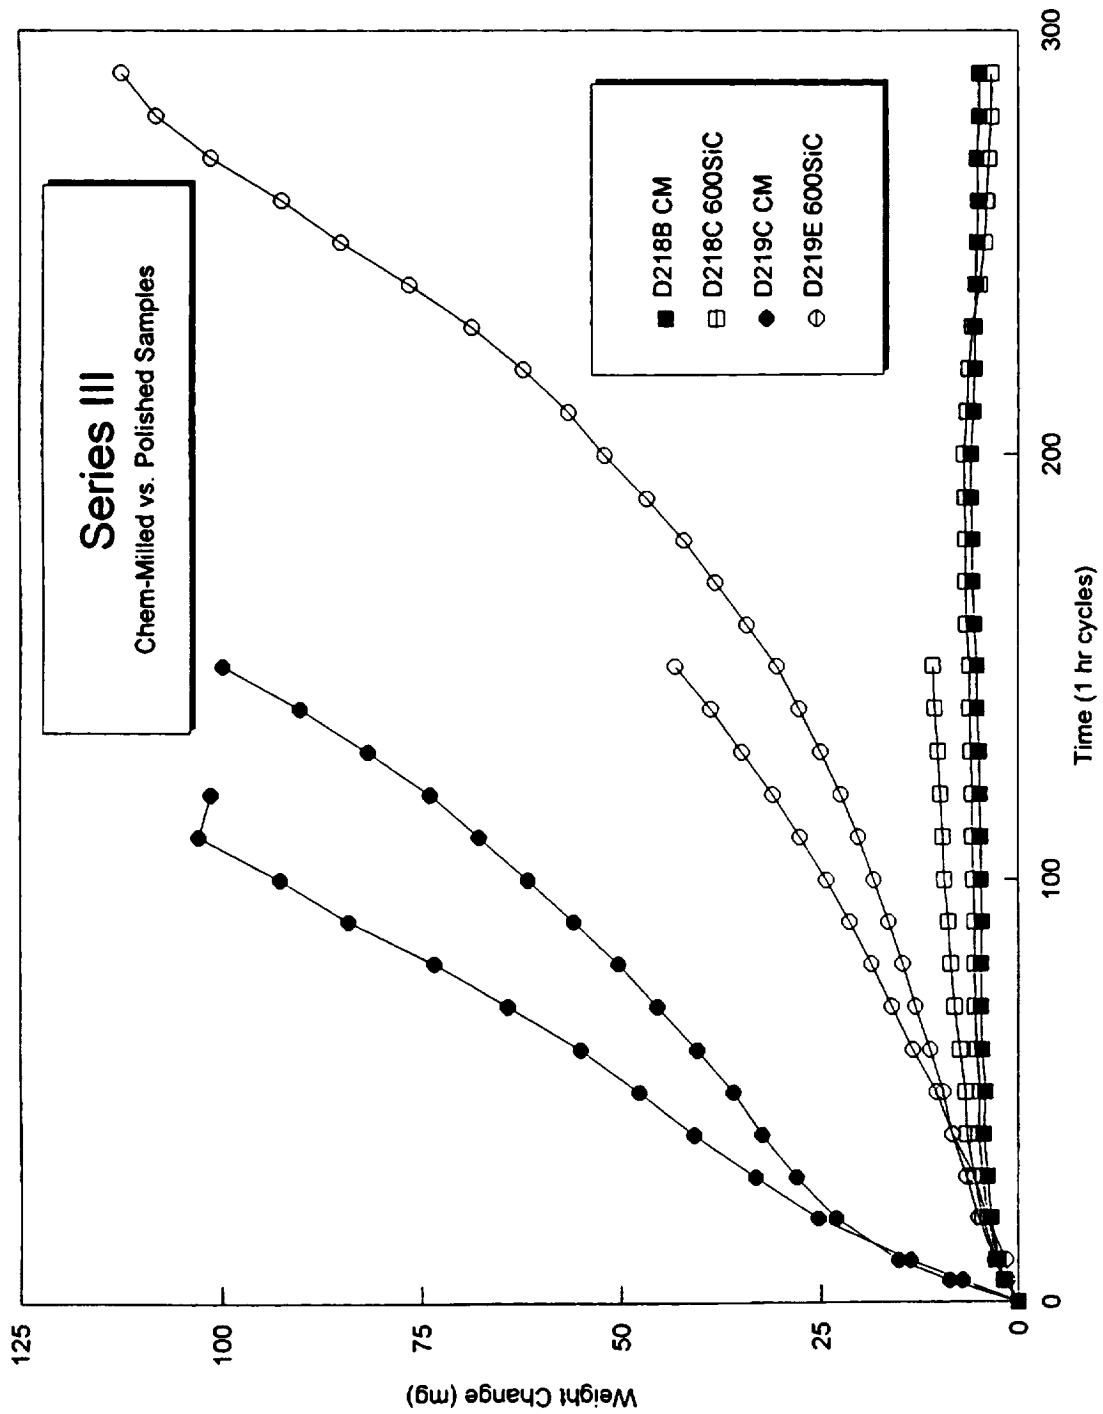
Mechanically polishing the surface of D219 through 600 grit SiC paper increased the time before the onset of rapid weight gain (Fig 38). Mechanically polishing the baseline alloy D218, which already exhibited good resistance to hot corrosion attack, had little effect on the weight change. Hence, mechanically polishing the surface appears to improve the hot corrosion behavior, at least for the alloys with poorer hot corrosion resistance.

There were significant differences in the hot corrosion response between samples which were chemically milled and those mechanically polished through 600 grit SiC paper. The lower weight gain of the mechanically polished samples (Fig 38) is reflected in the corrosion morphology after 50 hrs, as shown in Figs 71 and 72. Small distinct mounds are apparent on the surface and ends although one of the samples (D219F) exhibited a localized, scaly reaction product on one portion of the curved surface (Fig 71c). The growth of the corrosion mounds after 300 hrs on D219E is shown in Fig 73. In contrast to the mechanically polished samples, most of the surface of the chemical milled samples showed a relatively uniform and continuous attack (Figs 74, 75) although one end of D219D exhibited the distinct mound formation (Fig 74a). The uniform attack on the curved surface of the chemically milled samples shows the cast dendritic structure in relief (Fig 75c), again indicating that the growth of the hot corrosion attack is inward. Although the uniform attack gives an appearance as being less severe than the large, distinct mound formation, the depth of the attack was sufficient that after only 100 hrs, large, relatively thick corroded layers began to spall from the curved surface (Fig 76). Some of the cast dendritic structure is still apparent in the intact surface (Fig 76d).

Fig. 38 Weight change during burner rig testing for Series III, chemically milled (CM) versus mechanically polished through 600 grit SiC (600 SiC) surface finishes (D218 and D219 alloys).

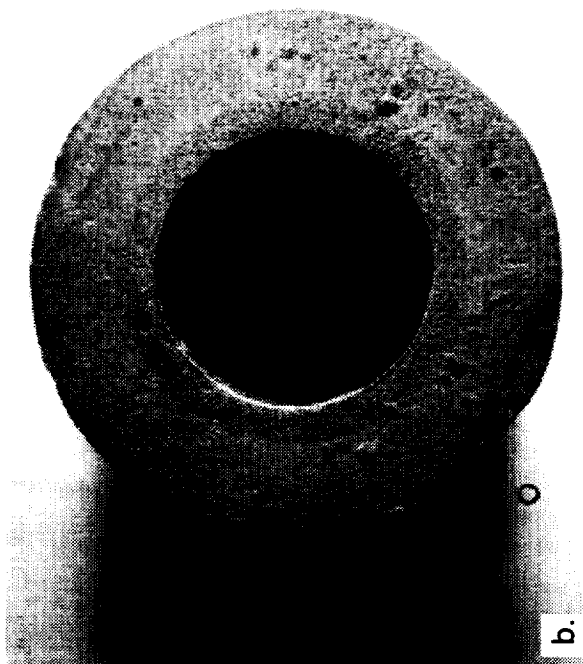
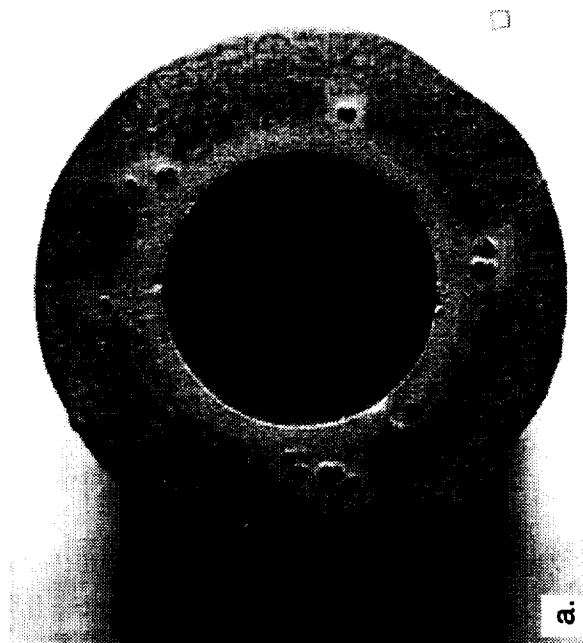
The AFN19 alloy exhibited a minimal amount of hot corrosion attack on the surface consistent with the low weight gain during testing. A small number of corrosion "mounds" are shown on the ends and curved surface of the AFN19 sample in Fig 39. SEM micrographs of the end shown in Fig 39a reveal significant porosity and fine cracks in the outer (Fig 40b) and inner region (Fig 40c) which resulted from the electropolishing and chemical milling treatments. The radial location of the mounds on the ends (Fig 39a,b) do not suggest any increased tendency for formation in the inner region with the higher pore density or the outer region with the larger number of fine cracks. Moreover, it is noteworthy that this sample exhibited good hot corrosion behavior while containing significant pores and cracks. EDS spectra of the three regions numbered (1), (2) and (3) in Fig 40b are shown in Fig 41. The porous inner region (1) and the darker smooth scale (2) contain significant levels of Ca and Mg, and smaller levels of Ni, Si, O, Al and S. Fe, Cr, Si and sometimes Mn were also commonly detected on the surface. These elements are deposited onto the samples during hot corrosion testing by the deterioration of Fe-based alloys used in the burner and nozzle (Appendix A). Since many of the alloys contain 1-2% Cr, and all of the alloys contain small levels of Si, it is difficult to determine the source of the Cr and Si detected on the surface, whether from within the alloy or deposited from the burner. However, Cr and Fe were detected on the surface of D218, which contains no Cr. Hence, at least some Cr and Si deposition from the burner is likely when Fe is also detected. Surprisingly, no Na was detected on the surface of any of the samples. The EDS spectra taken from the top of the mound in Fig 40b (location 3) shows high levels of Al, Ni and Ca. The ratio of these elements was common for the top of mounds on many of the samples.

Fig. 39 Optical macrographs of AFN19 after 300 cycles, (a), (b) ends, and (c) curved surface.

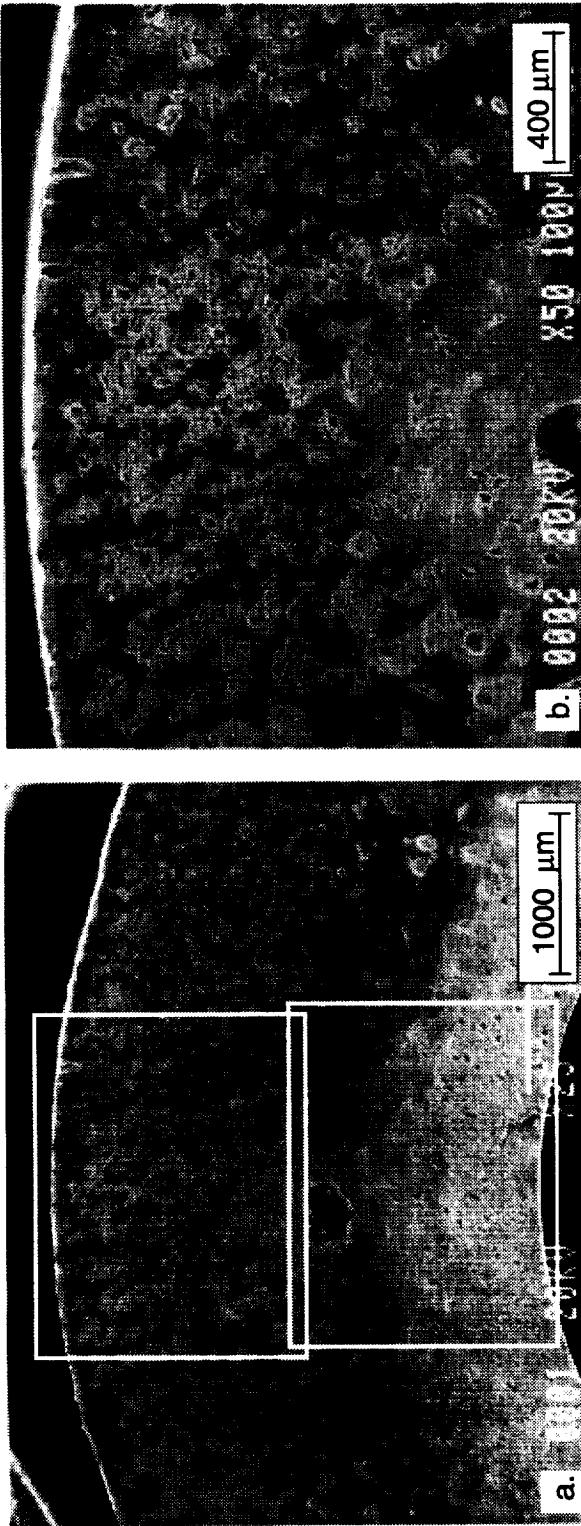
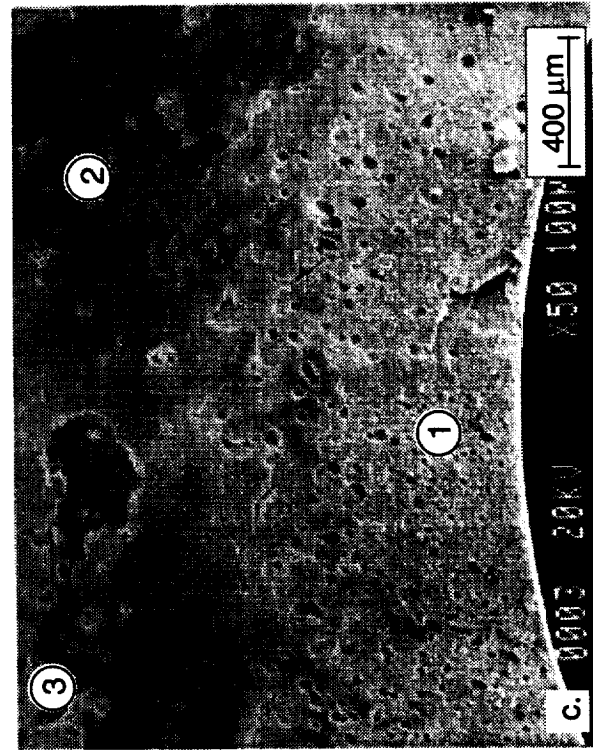
Fig. 40 SEM micrographs of (a) end of AFN19 shown in Fig. 39a, (b) and (c) are magnified views of the ID and OD edges. Arrow in (b) points to a corrosion mound.

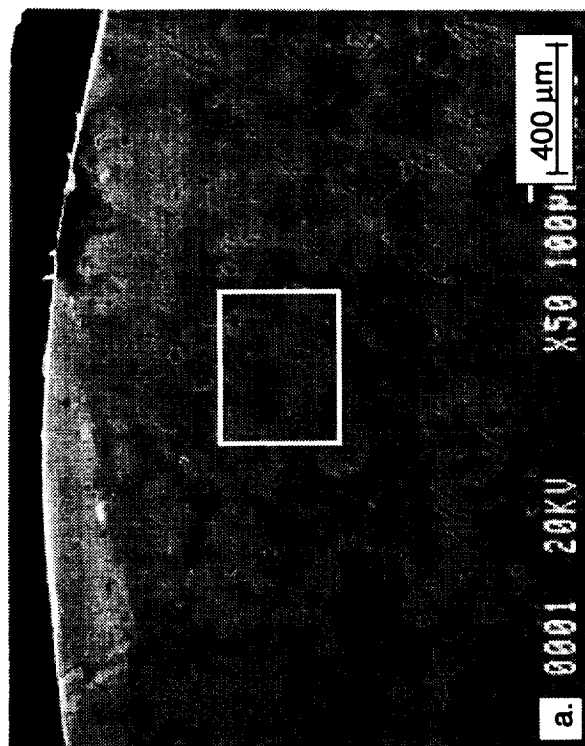
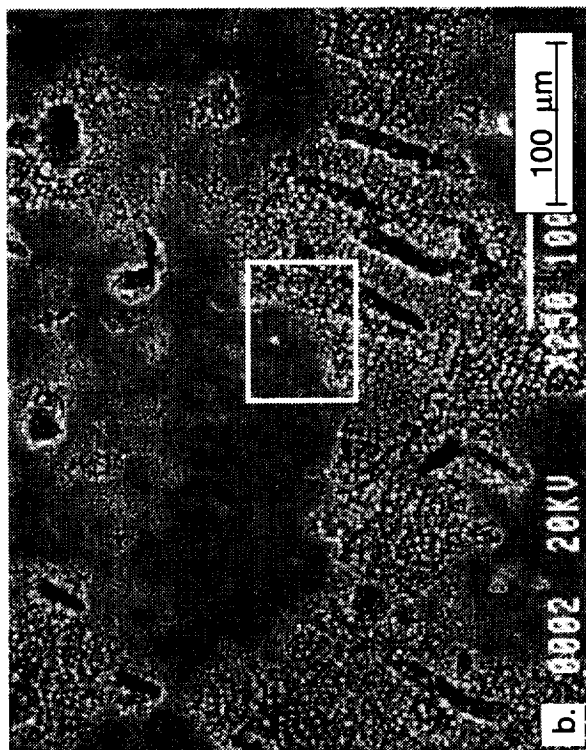
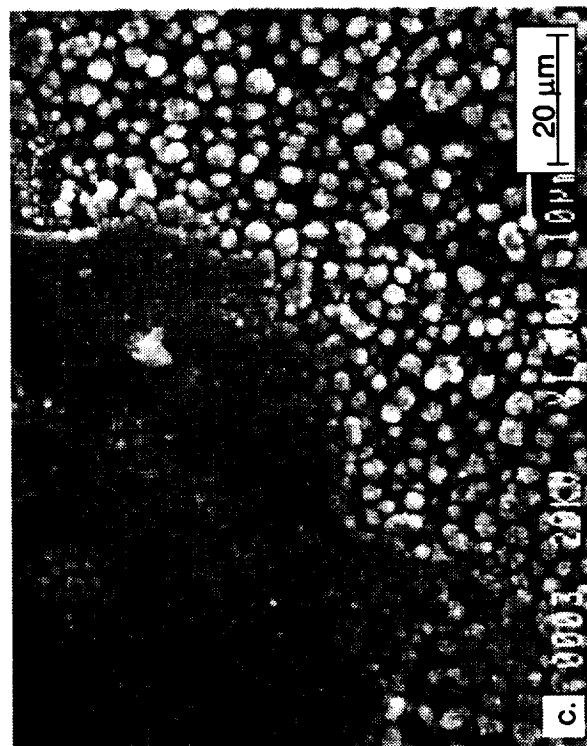
Fig. 43 SEM micrographs of end 2 of AFN19 after 300 cycles, (b) and (c) are magnified views of (a) and (b).

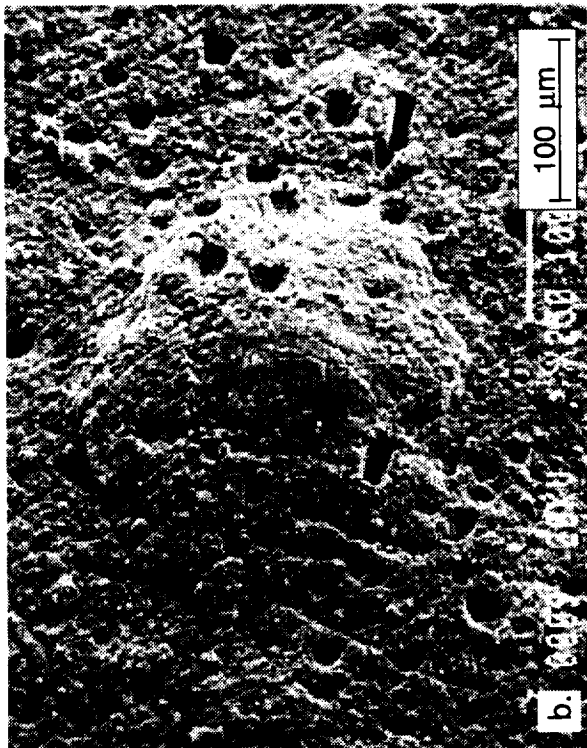
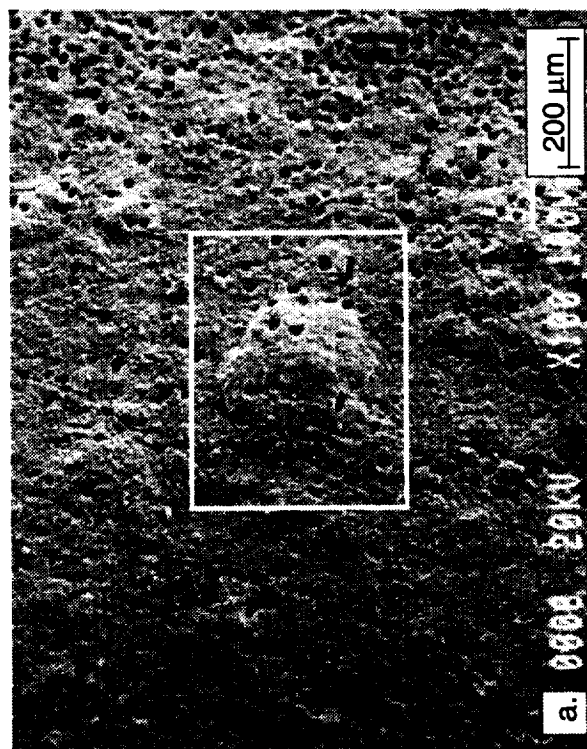
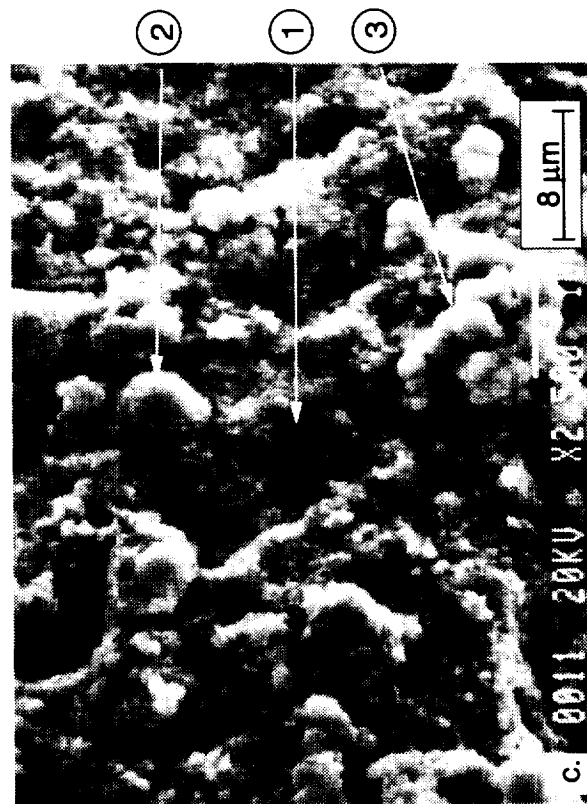
Fig. 47 SEM micrographs of the curved surfaces of AFN19 after 300 cycles showing corrosion mounds (b) is a magnified view of (a) and (c) is a magnified view of the top of mound in (b).

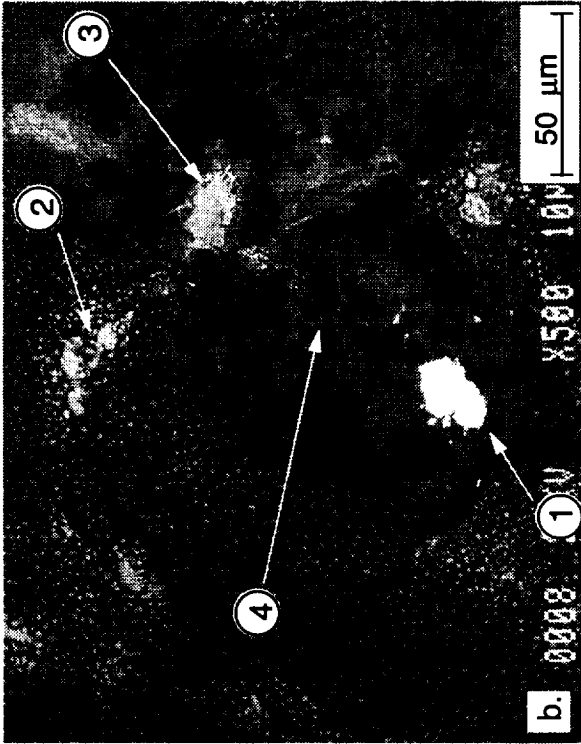
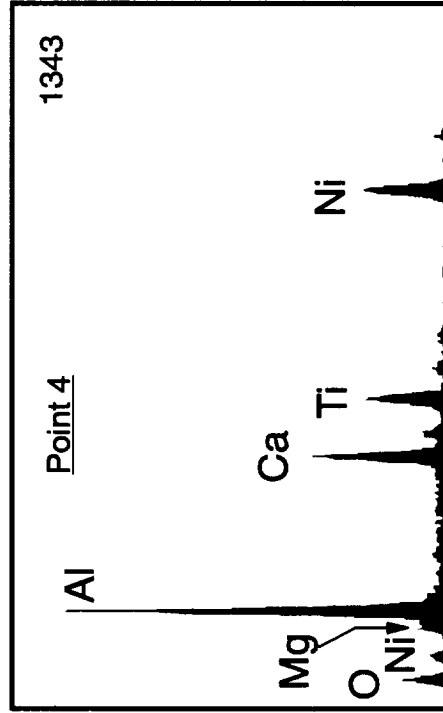
Fig. 61 SEM micrographs of the top of a corrosion mound on the rough end of AFN20 after 300 cycles, (a) SEI image, (b) BSE image, and (c) EDS spectra of point 4.

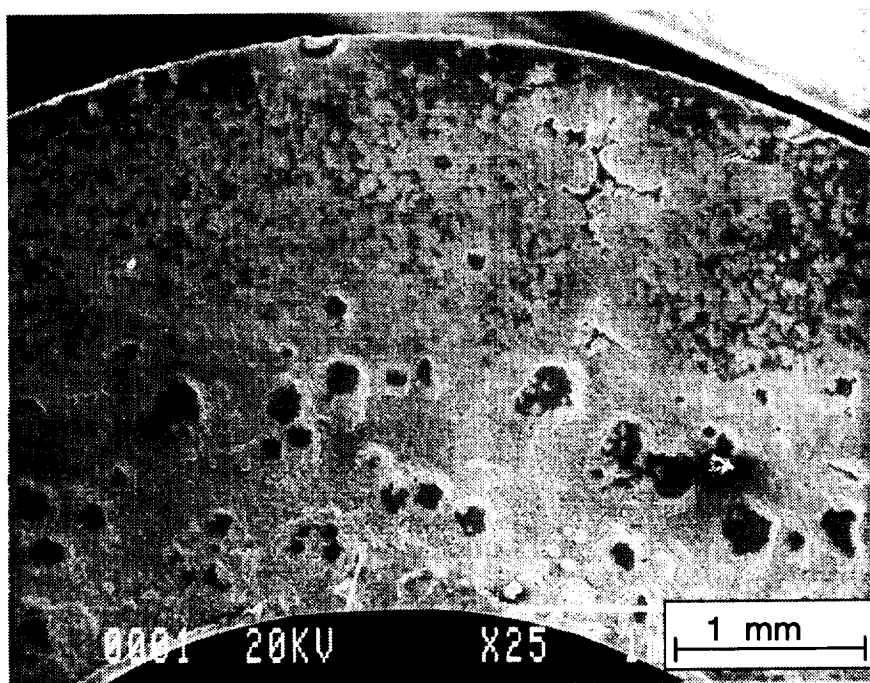
Fig. 62 SEM micrograph of the smoother end of AFN20
(see Fig. 59b) after 300 cycles.

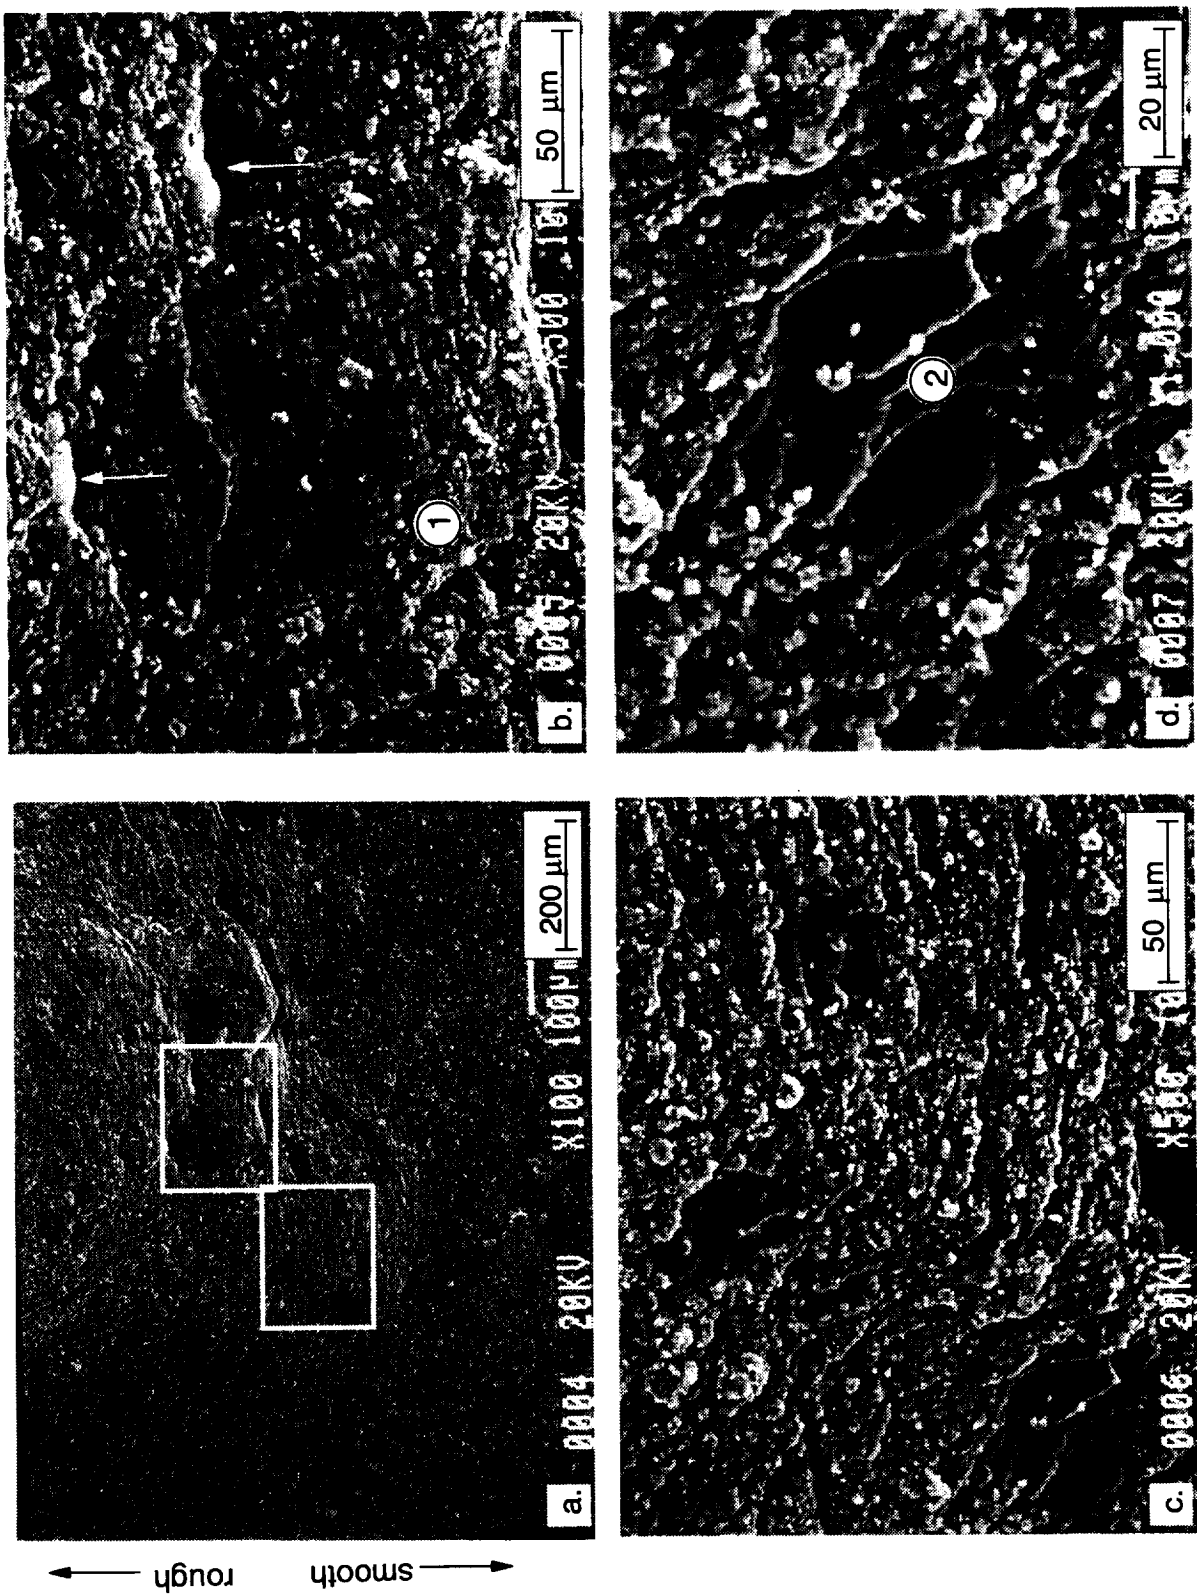
Magnified views of the corrosion morphology on the curved surface of the AFN20 sample are shown in Figs 63 and 64. Fig 63 shows the rough, heavily attacked, left end of the sample shown in Fig 59c. EDS analysis of the scale shown in Fig 63c shows the typical Ca-rich oxides with a significant level of Al and lesser amounts of Fe, Ti, Ni Si and S, closely resembling that shown in Fig 46a. Fig 64 shows the surface near the center of the sample shown in Fig 59c at the edge of the heavily attacked "rough" and less-attacked "smooth" region. The "ledge" type structure shown in Fig 64b (area 1) shows a fine structure similar to the etched and chemically milled surface, such as that shown in Figs 17a,c and 24a. The EDS spectra for this ledge is high in Al and Ca similar to that in Fig 42d, only with the addition of substantial Fe and Si. An unidentified oxide appears to be growing out of cracks in the plates (see arrows). The brightness of the oxide suggests NiO which is an outward growing oxide. Dotted across the side of the corrosion mound are dark plates, as shown in Fig 64c,d. EDS analysis of the plates showed that they were high in Ca and Ti with smaller amounts of Al and Ni and a trace of Hf (Fig 65). This is the only alloy in which these Ti-rich plates were observed. Figure 66 shows the scale in the less attacked, "smooth" area of the sample (right end of Fig 59c,d). The EDS spectra (Fig 67a) of the large nodule/particle shown in (c) indicates a high Ca content, as well as significant S, Fe and Ti. The presence of Ca, S and Fe suggest that the particle may have

been deposited on the surface rather than grown as a result of corrosion although the significant Ti level suggests a reaction with the alloy. The two smaller mounds in (b) and (d) suggest an inward growth process is occurring causing the outward projection of the mound. Since all indications are that the corrosion reaction proceeds inward, it is not surprising that the EDS spectra of the surface of the small mound shown in (d) (Fig 67b) appears similar to that of the nodule/particle shown in (c) (Fig 67a). Chemical inhomogeneity appears the only reasonable explanation for the rampant attack on only a portion of this sample.

Fig. 64 SEM view (a) overlapping the rough and smooth regions on the curved surface of AFN20 after 300 cycles, (b) and (c) are magnified views of upper and lower boxes, respectively, in (a), and (d) is magnified view of (c).

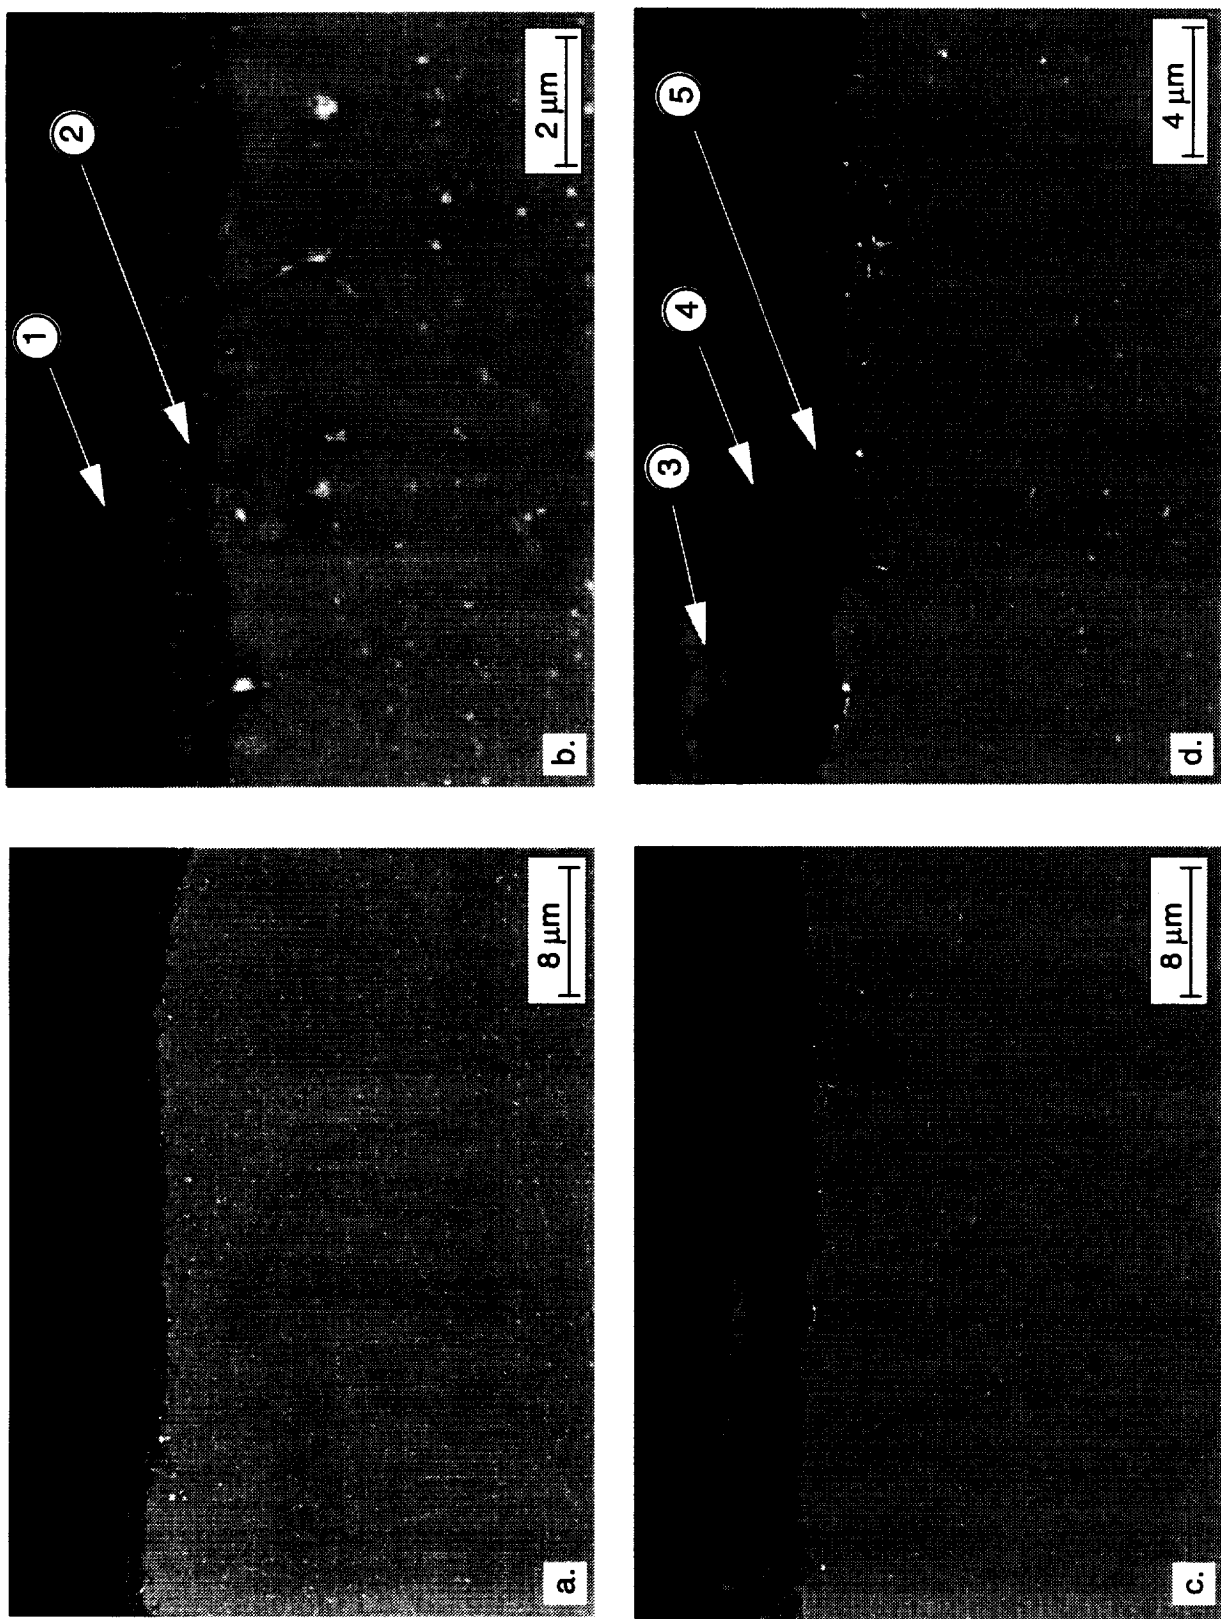
Fig. 83 "Pre-initiation" scale in (a,b) D218 and (c,d) D219. Numbered locations correlate with EDS spectra in Fig. 84.

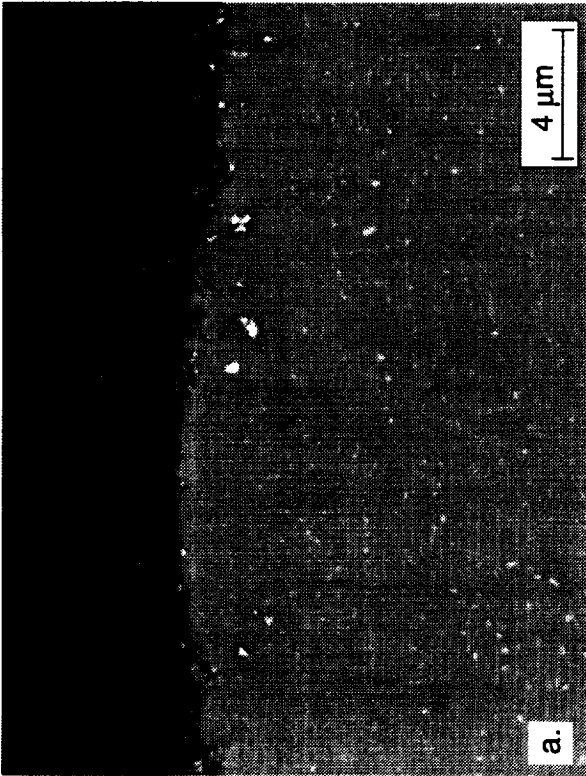
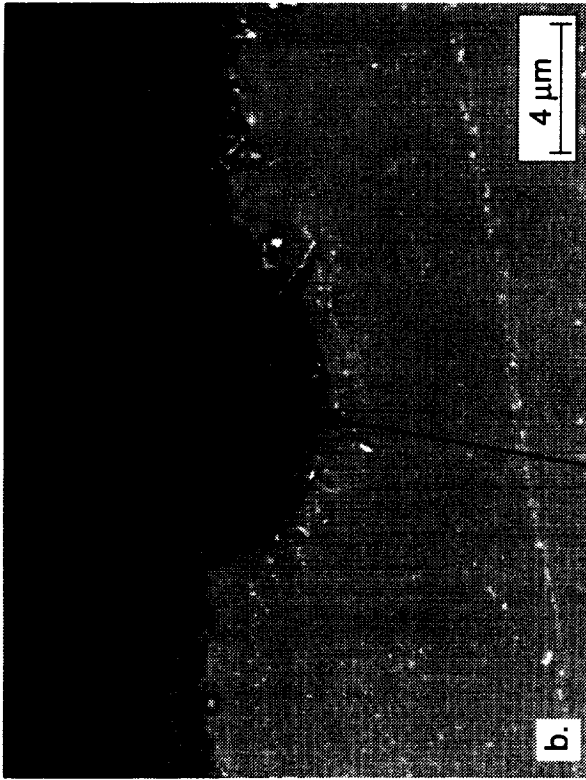
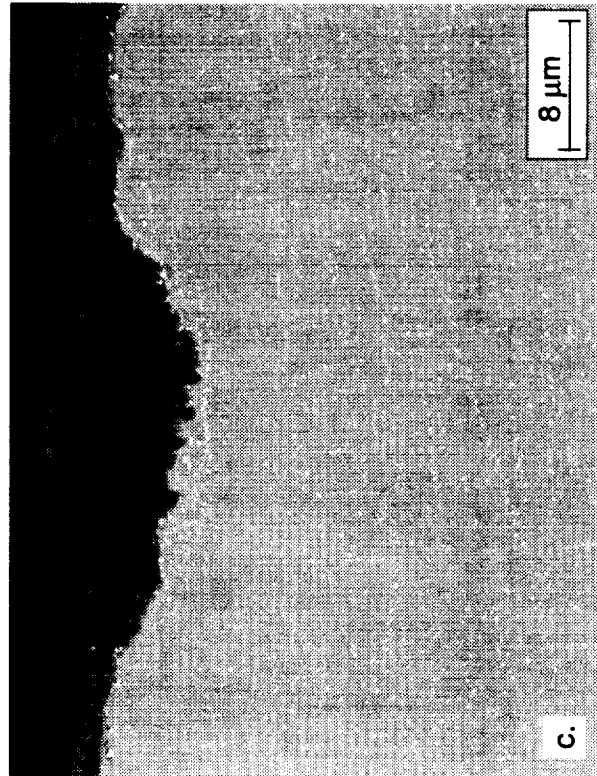
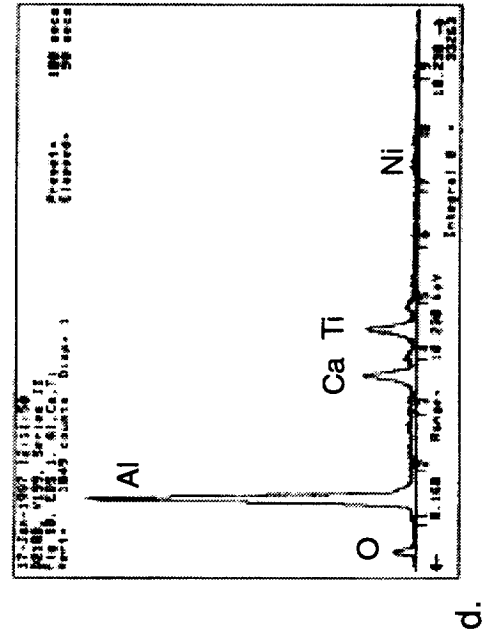
Fig. 85 Possible initiation sites in D218, (a) thicker, fractured scale, (b) "bulb" shaped pit (c) broader, shallow pit, (d) EDS spectra from pit in (b)

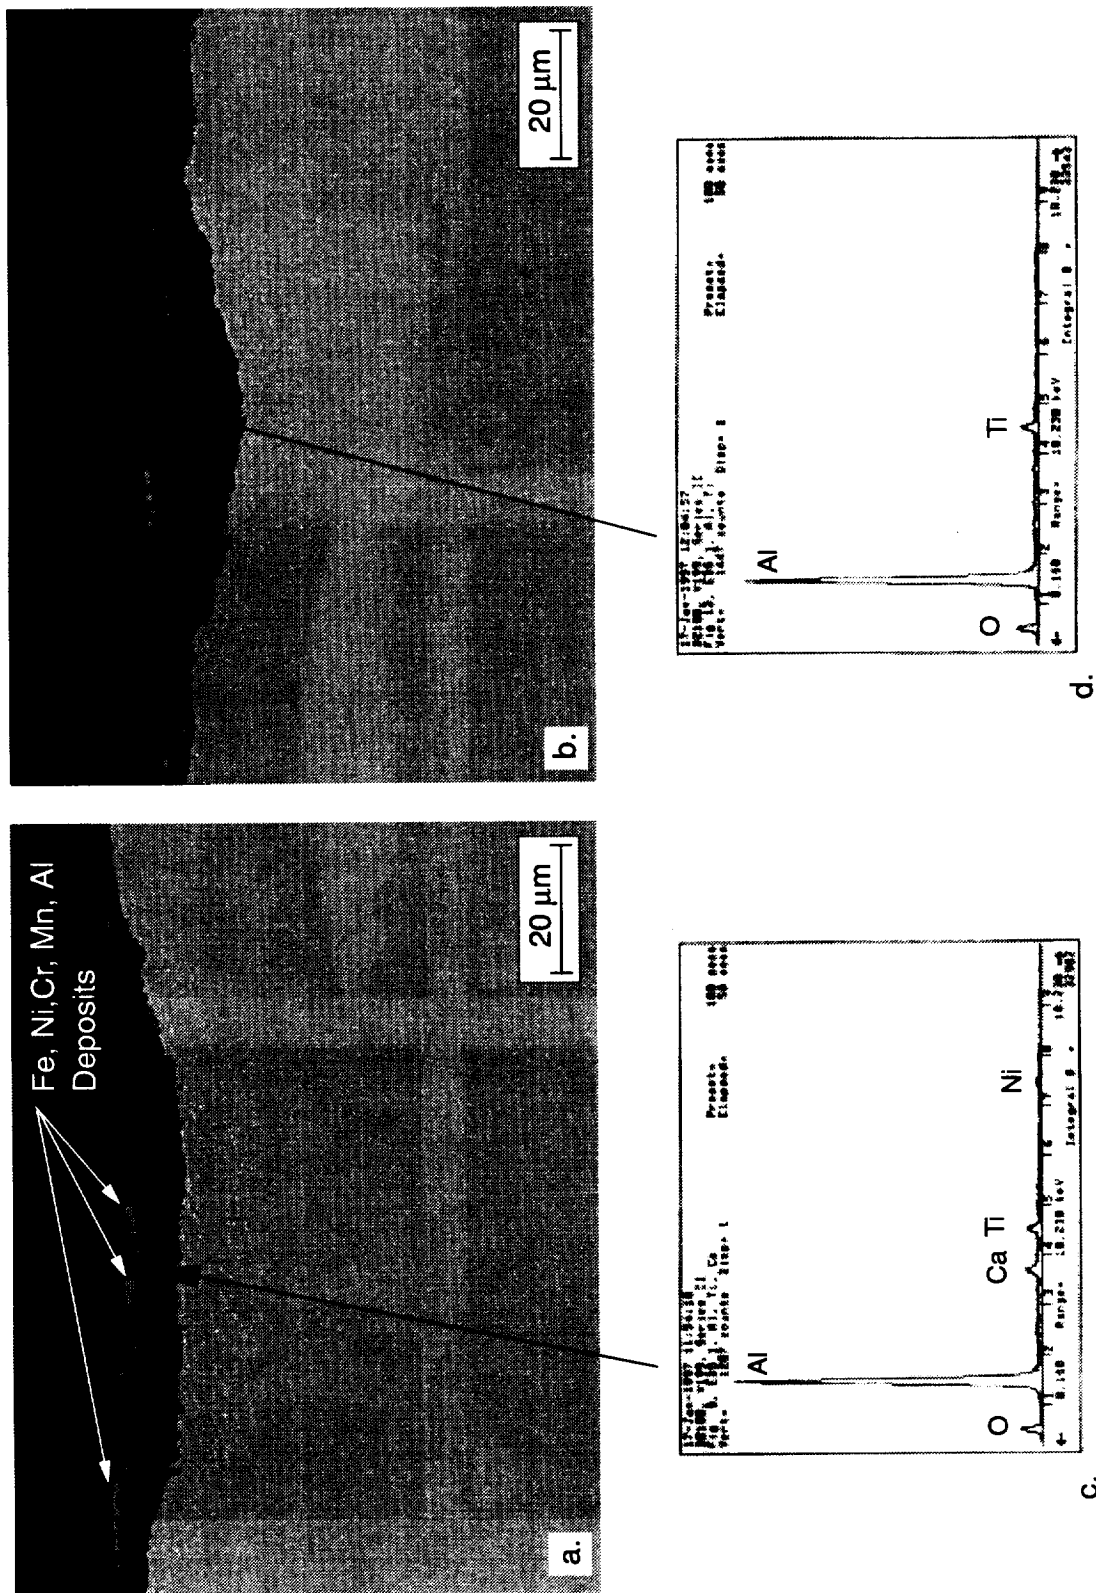
Fig. 86 Possible initiation sites in D218, (a) shallow, sunken pit and (b) shallow but raised pit, (c,d) associated EDS spectra from the center of the pits.

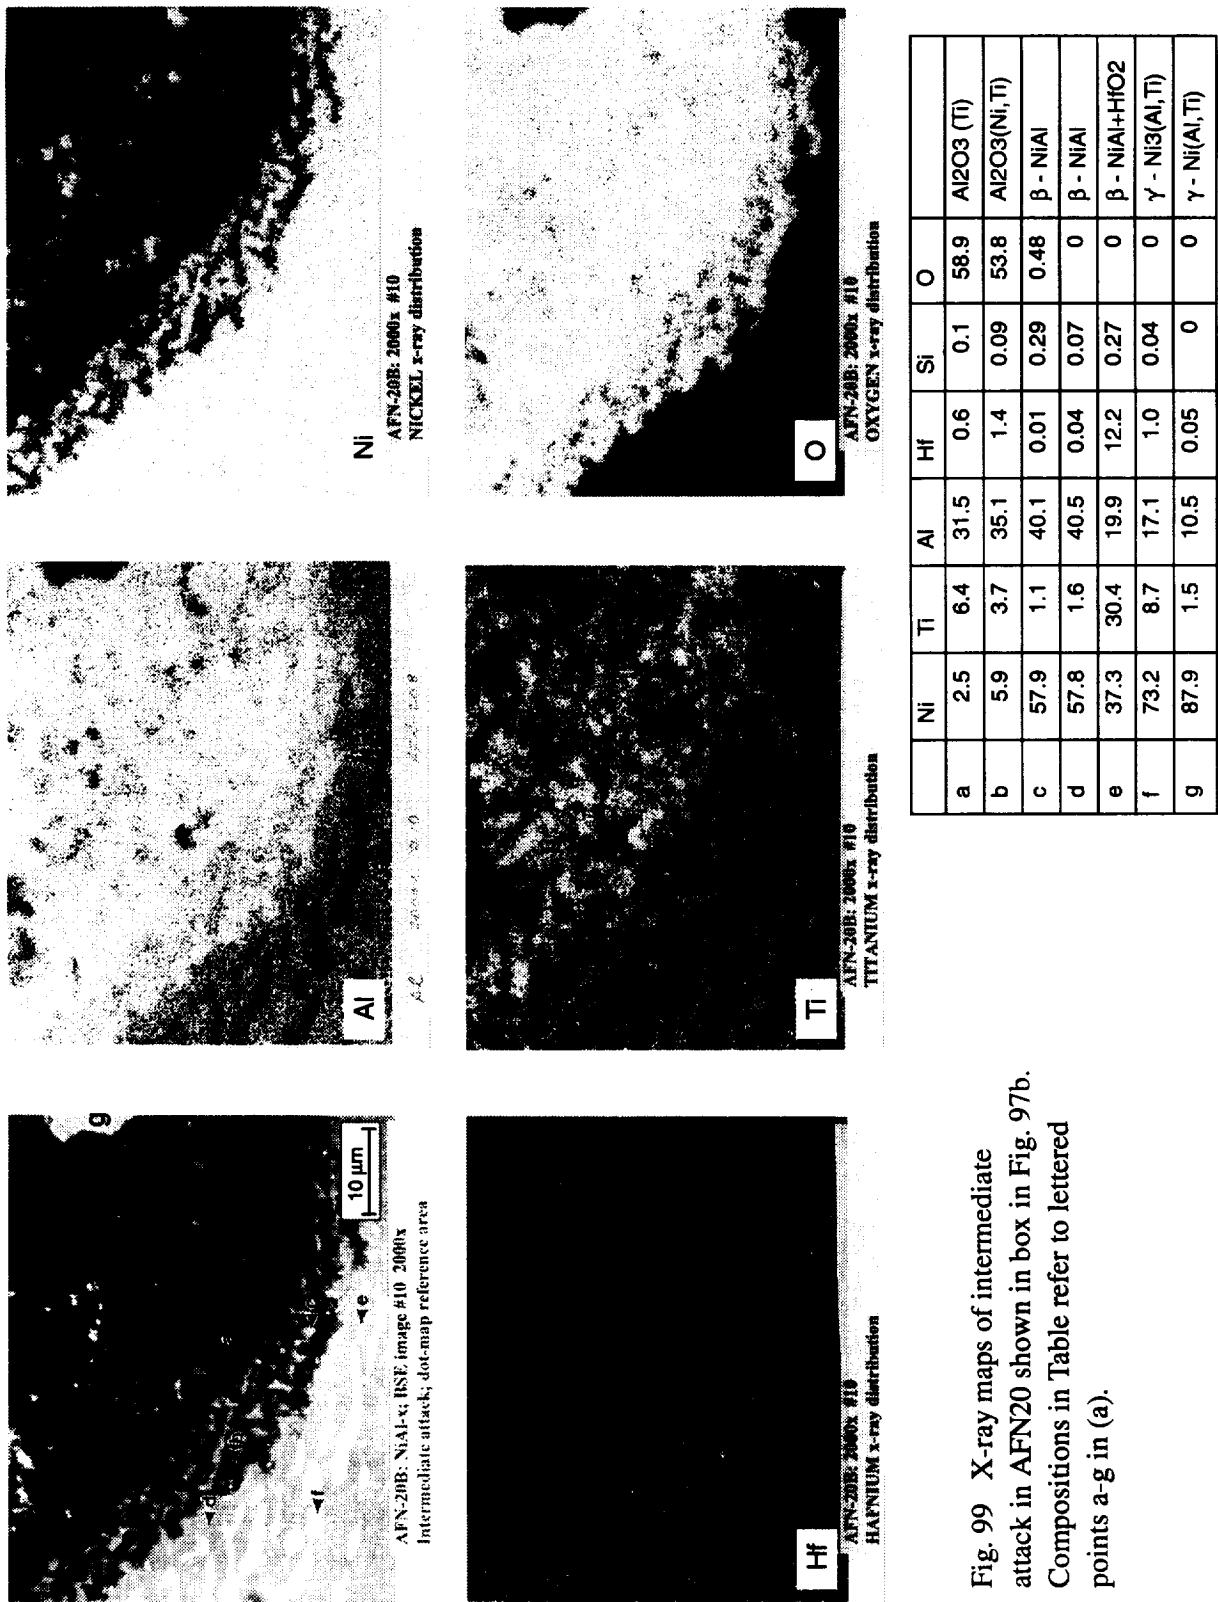
Fig. 99 X-ray maps of intermediate attack in AFN20 shown in box in Fig. 97b. Compositions in Table refer to lettered points a-g in (a).
